KemaSeries60 Module Sealant — A Pipeline Recoat Project

The Coating
Chronicles
January 2002

A few years ago our Service Group, Mi-mar Expert Coatings, Inc. was contracted to complete repairs and a recoat for a continuous 1000 feet length of a 12" OD oil products pipeline that ran under a major eight-lane highway on the island of Montreal in Canada.

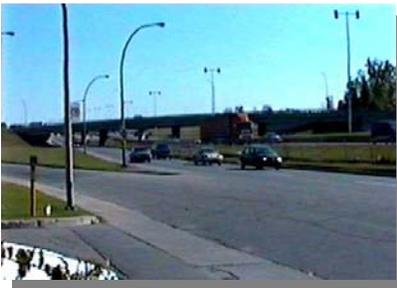
Atop storm drain at road level looking out and across access road to highway.

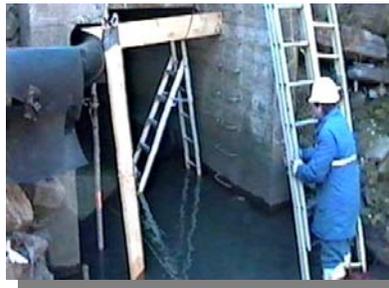
Looking down at water-filled tunnel entrance.

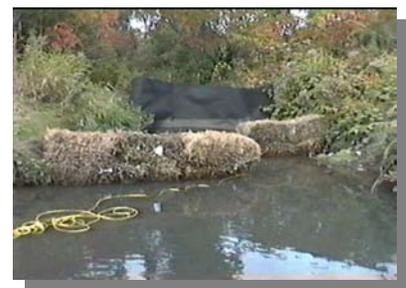
Water run-off from tunnel feeds creek that needed protecting.

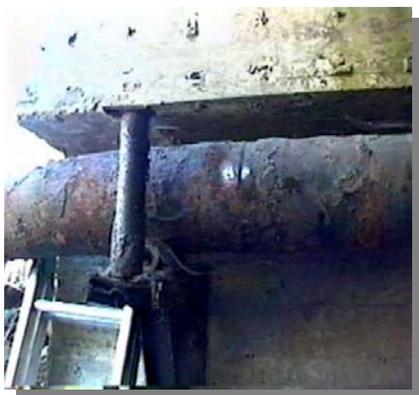
The closer to each entrance one was the more serious the pitting and corrosion cells. As one proceeded further into the tunnel the protective coating appeared to be more intact however very weak interfacial adhesion was also observed.

The destructive result of coating loss, environmental exposure and time.

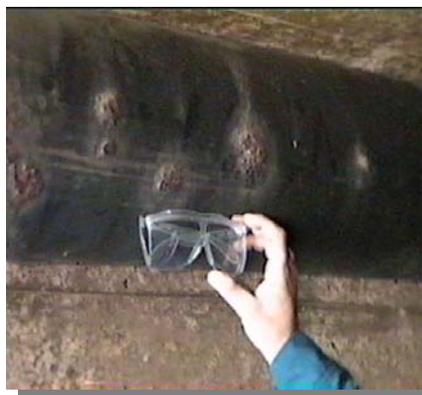
Poor surface preparation and continuing moisture produced these corrosion cells.

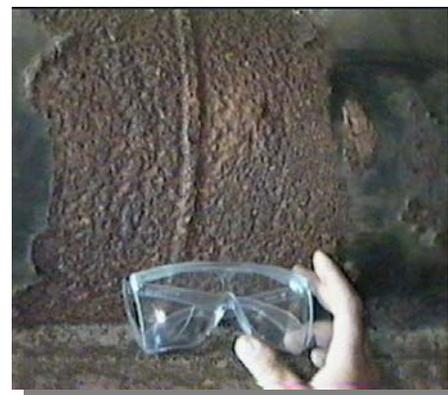
Precise pit depth readings were taken to help assess extent of damage.

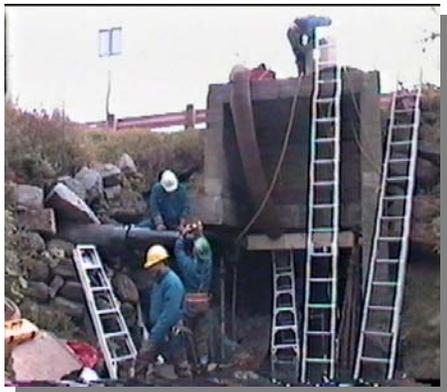
Safety practices included escape ladders harnesses and supplemental air supply.

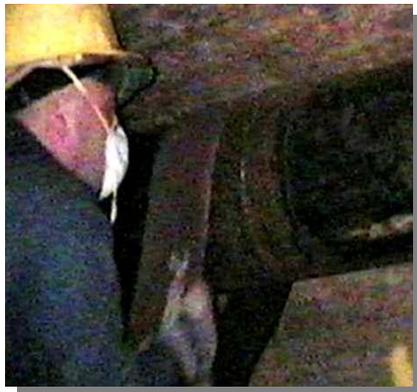
Underground—where pipe cleaning with aluminum oxide paper is the norm.

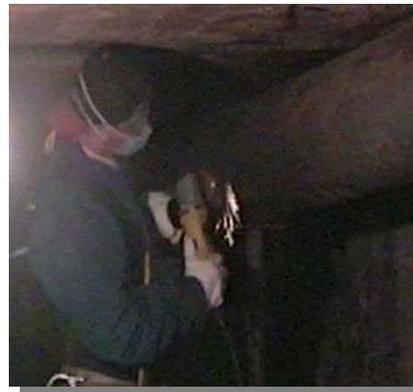
Power wire brush cleaning in preparation for liquid primer application.

KemaSeries60 Module Sealant, a 65 mils. thick coating, was chosen to protect the exterior of both the casing pipe and the product pipeline. It was applied with a 50% overlap over a cured, specified, liquid primer following a Power Wire Brush cleaning. Total thickness was 130 mils.

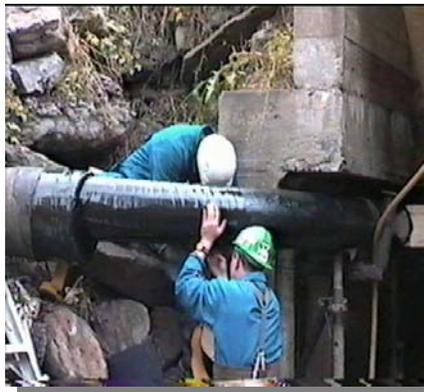
Casing end was first sealed then both pipes were wrapped with KemaSeries60.

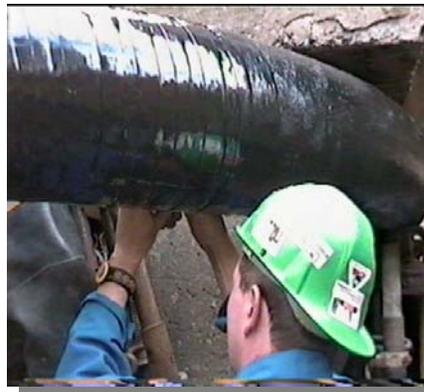
6" wide KemaSeries60 was used with a 50% overlap.

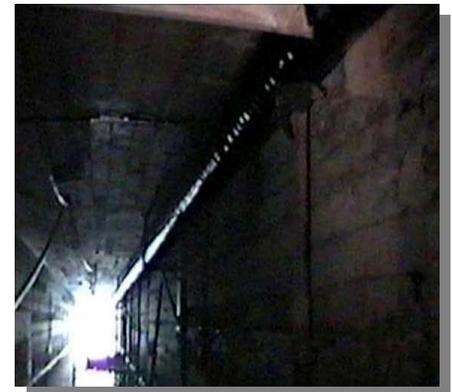
The final view from within. The recoated pipe in place and awaiting deliveries.
