KemaSeries60 Module Sealant — A Pipeline Recoat Project

The Coating
Chronicles
January 2002

A few years ago our Service Group, Mi-mar Expert Coatings, Inc. was contracted to complete repairs and a recoat for a continuous 1000 feet length of a 12" OD oil products pipeline that ran under a major eight-lane highway on the island of Montreal in Canada.

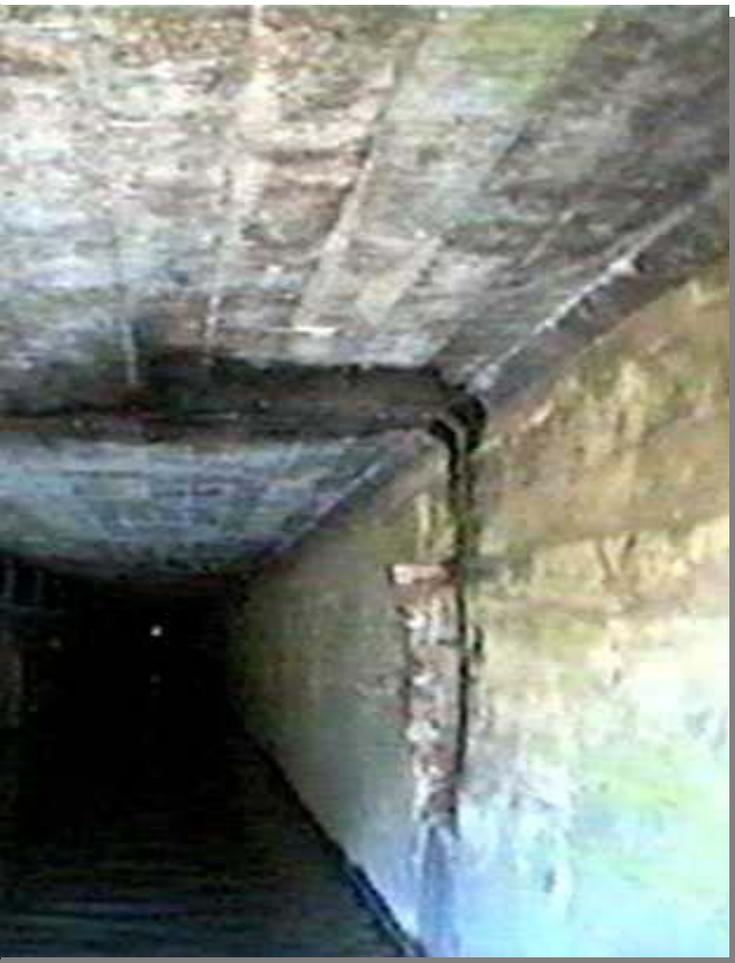
including the wall mount screws and the attached rubber roller kits had been installed uncoated. Many brackets were in an extreme state of metal loss and advance corrosion. The rubber rollers had long since become dry, cracked and many had split under the weight of the pipe.

A Kema liquid epoxy was used to coat the steel pipe brackets after each was sandblasted to NACE 2. The Kema epoxy was also injected into the bracket bolt holes and each bolt was first dipped in the epoxy before it was installed. Epoxy dry film thickness was 20 mils. minimum.

Replacement rollers were of urethane.
